RE: **ADDENDUM NO. 1**
RECONSTRUCT STORM DAMAGED BIKE PATH AND SHOULDER ON PARK AVENUE

TECHNICAL MEMORANDUM

RE: Design Alternatives Memorandum - Revised
Park Avenue Slope Repair
City of Capitola, California
CE&G Document 180920.001

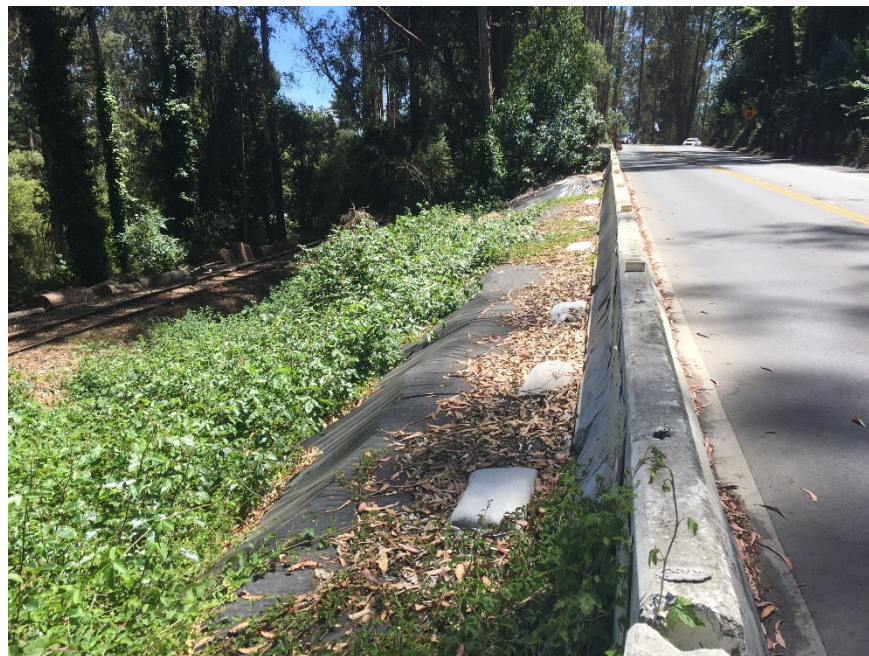
Photo 1. Slope Damage Along Park Avenue, taken July 7, 2018

The damaged slope is currently covered with visquine and sandbags to protect the uplifted and loose surficial soils from surface runoff and reduce potential for additional damage. Temporary concrete “K-rail” barricades are placed along the edge of roadway pavement within the limits of the damaged slope. Photo 1 below shows the current condition of the slope along Park Avenue.

The eastern slope along Park Avenue was damaged due to the toppling of trees, leading to uplift of the tree root balls causing movement along the slope. Based on site reconnaissance and our subsurface investigation, the damage appears to be shallow and only extend within the upper portions of the slope. Soils within the limits of the damaged slope are likely to be

loose and susceptible to erosion. Damaged areas include segments of bike lane where the roadway pavement lost support and failed, leaving the bike lane inoperable.
