RE: **ADDENDUM NO. 1**  
CAPITOLA BEACH FLUME AND JETTY REHABILITATION

# MEMORANDUM

**To:** Steve Jesberg, City of Capitola  
**From:** Brad Porter, PE *Brad Porter*  
**Date:** January 25, 2013  
**Subject:** Capitola Flume Rehabilitation-Concept Study  
**M&N Job No.:** 6628-01

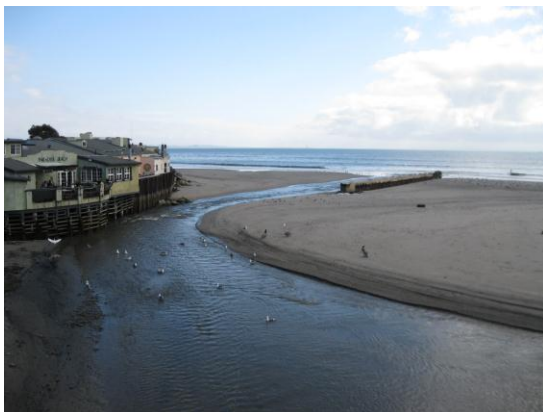
1-Soquel Creek at Capitola, Flume at Right

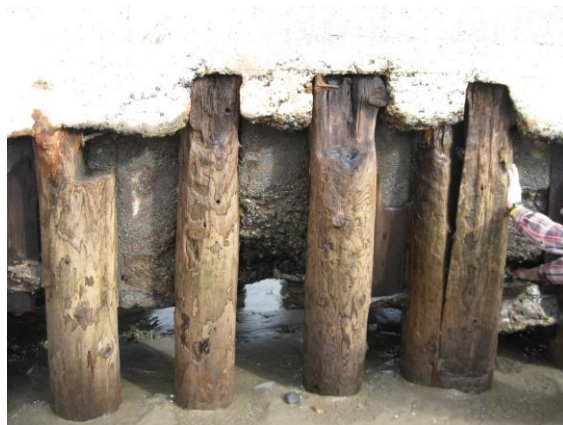
2-Flume Close up

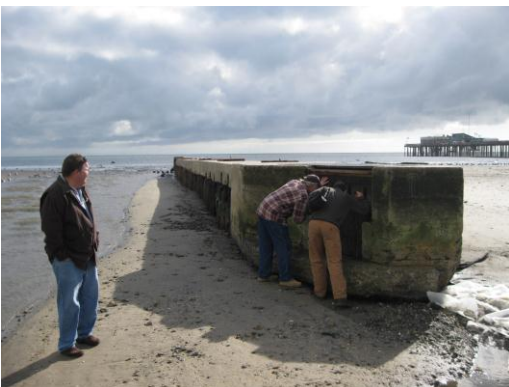
3-East side of Flume, Soquel Creek Open

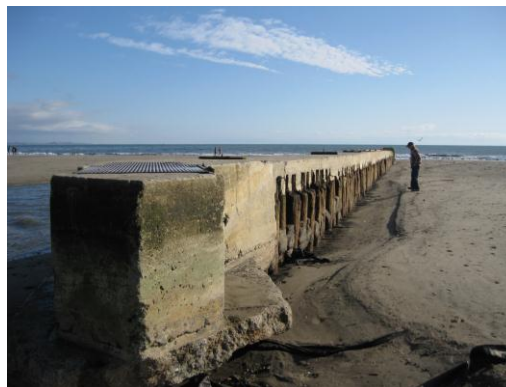
4-West Side Flume Inlet, Beach Sand Low

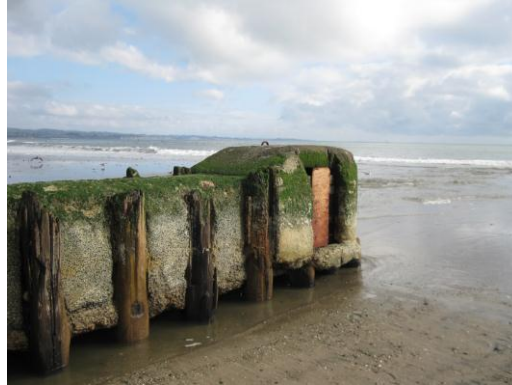
6-Flume Outlet

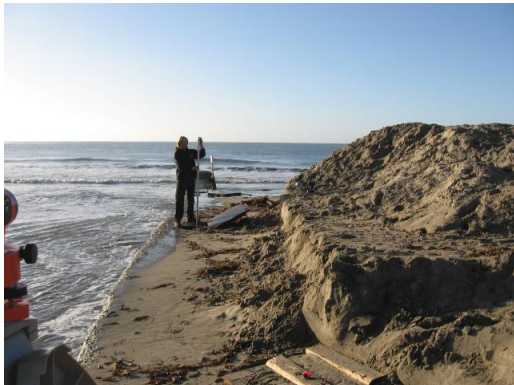
7- Flume outlet 9 am

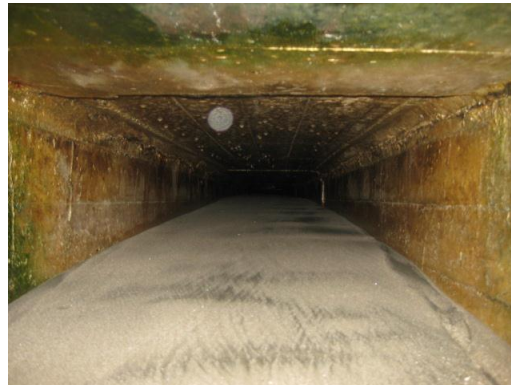
8-Inside Flume Filled with Sand Near Outlet 5pm

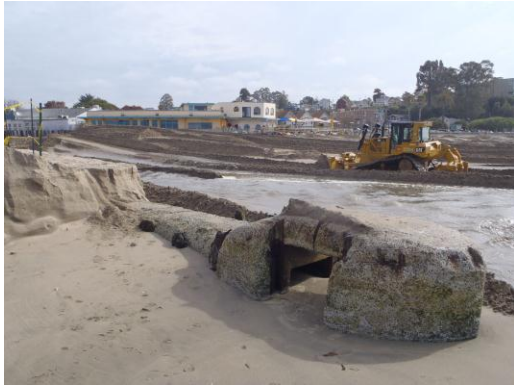
9-Outlet May 25

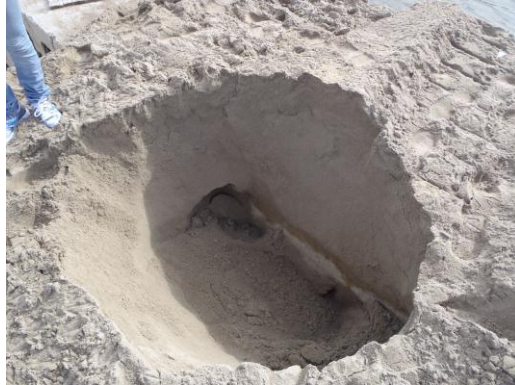
10-Sink Hole Near Inlet

Based upon the site visit observations it appears that the source of the sinkholes developing may not be due entirely to condition of the flume concrete. No significant cracks were observed in the bottom of the flume. There were a number of cracks or cold joints observed in the middle to top portion of the wall that would allow some leakage to occur. The operation of the flume is such that the water enters the inlet as a drop inlet: the water falls vertically into the box and has little initial horizontal velocity. Because of this, the box and flume are near full at the upper (inlet) end and consequently water could flow out the cracks in the middle and upper portions of the flume. As the water flows down the flume it increases in velocity due to the flume slope and reduces in depth such that it may not be high enough on the wall to leak out of the cracks on the upper portion of the wall.

The outlet of the flume is exposed to the wave and tidal action of the ocean which acts to erode the sand from under the flume. This may be the cause or a part of the cause of flow around the outside of the flume that allows a conduit for piping out of the sand.

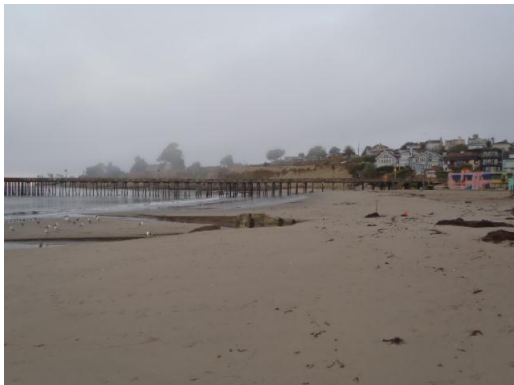
Observed operation of the flume with larger creek flow. It appears that the tide action may be undercutting the flume sand rather than leakage through the flume concrete. Both sides of the outlet were open to allow the larger flow to discharge.

11-Beach at Outlet, Looking West

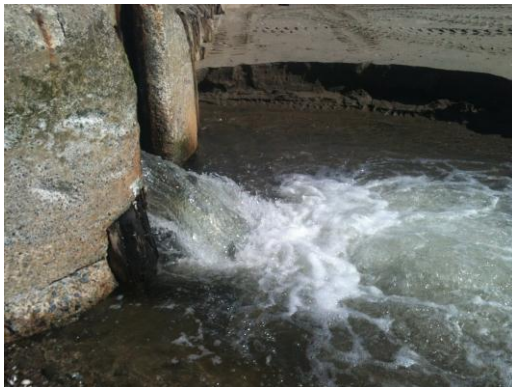
17- East Side Outlet Open

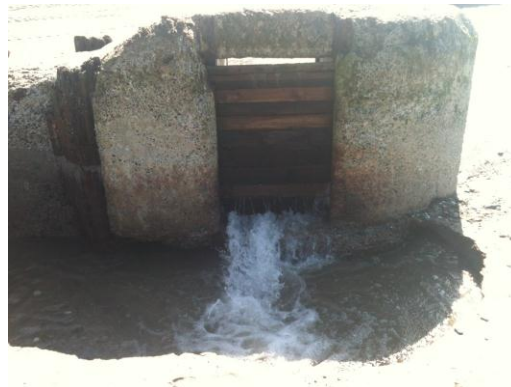
18-West Side Outlet Closed

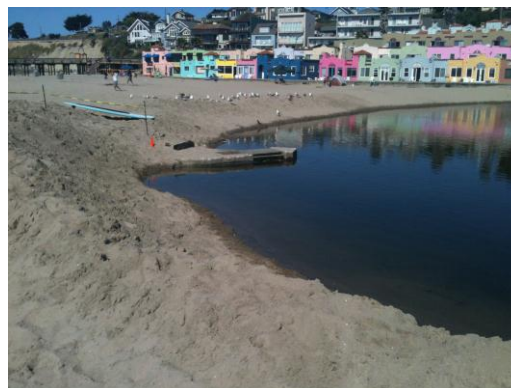
One side of the outlet is open. The flow is less than it was in late spring in 2011. No signs of sinkholes are apparent. Sandbags are placed at the inlet with plastic sheeting to stop piping around the exterior of the flume that would create voids in the sand.

20-Inlet at Creek Lagoon

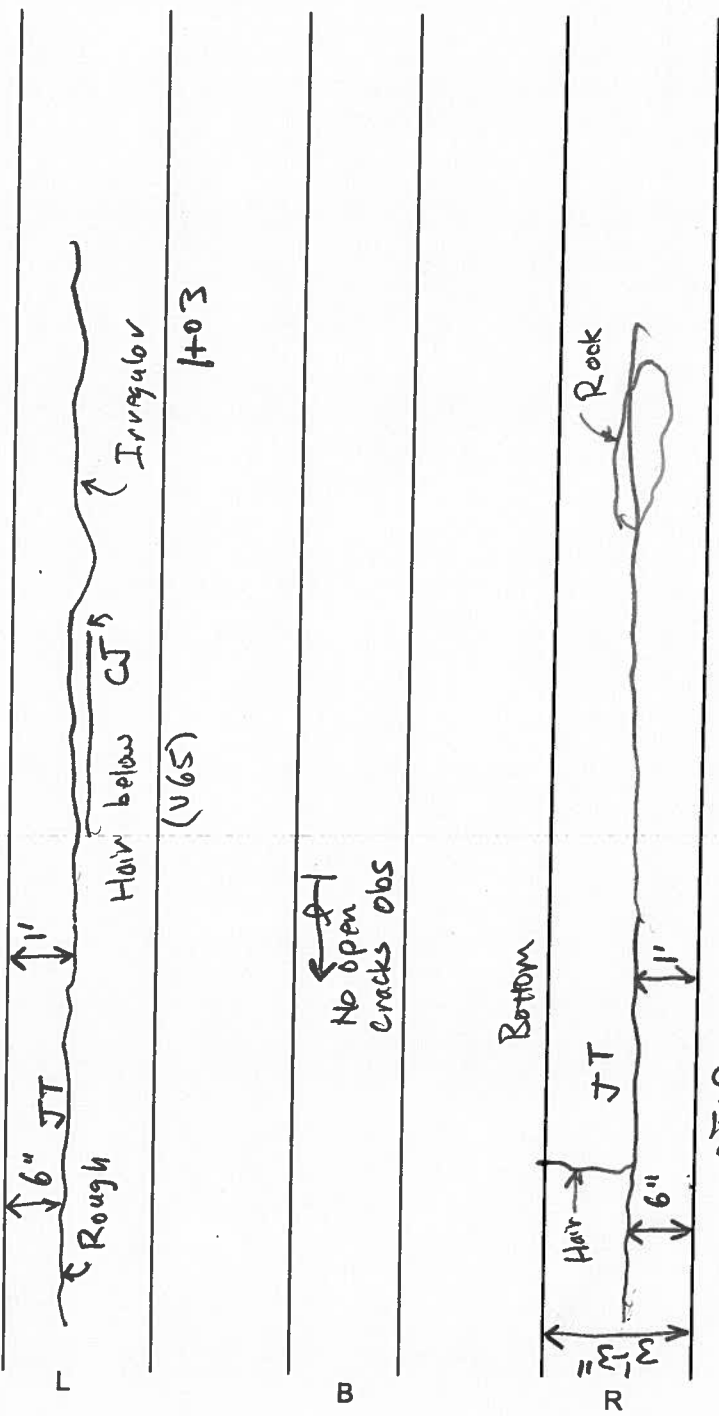
WALL ELEVATIONS

No open cracks obs

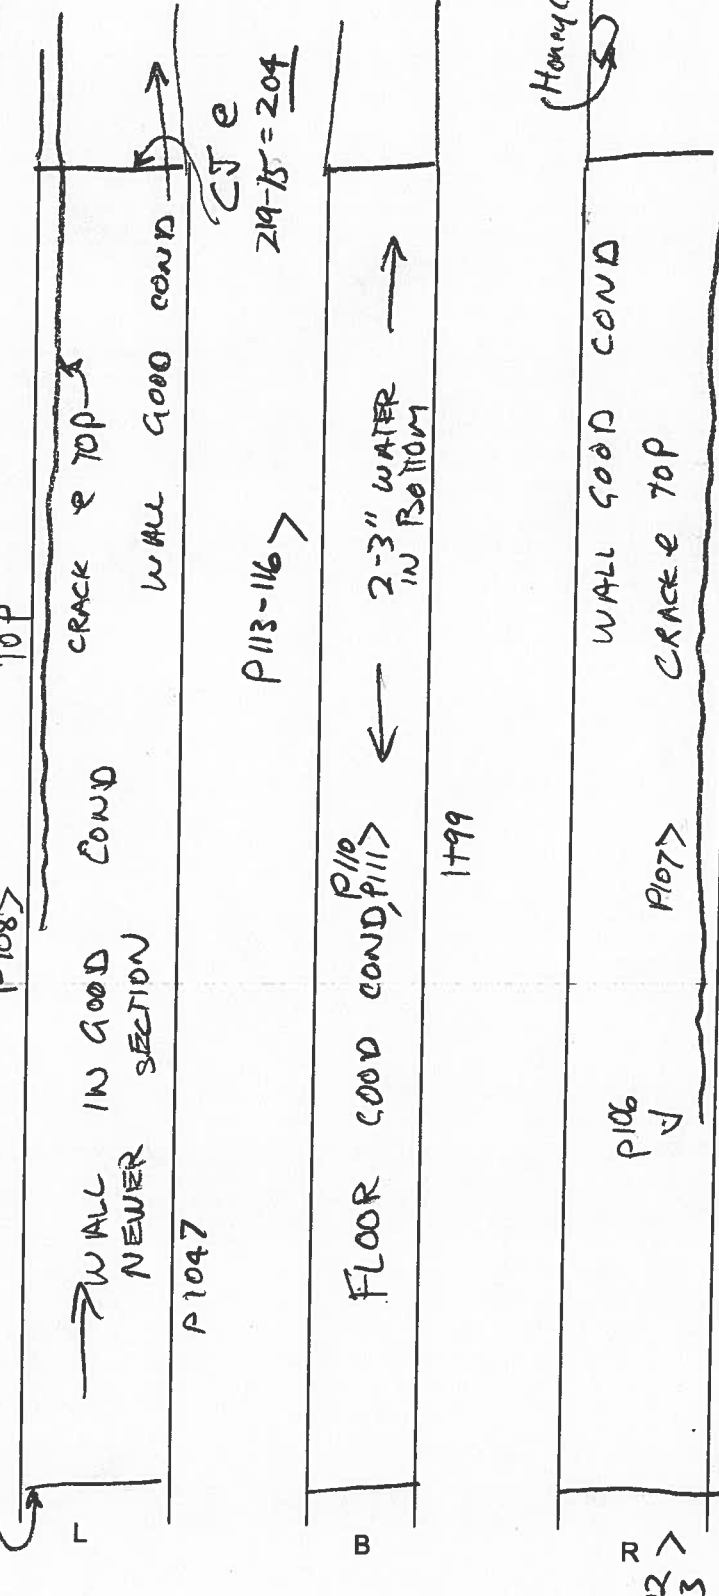
WALL ELEVATIONS

(Honeycomb)

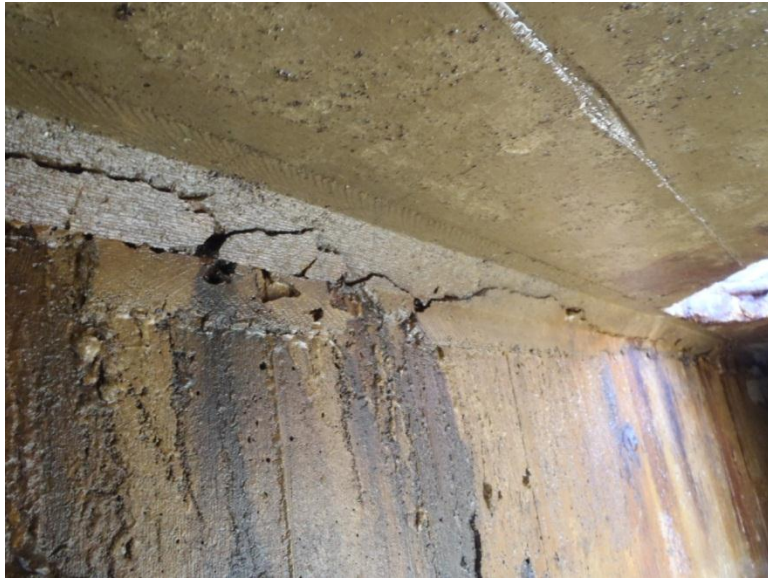
5) Sta 10 Right Side Top Long Crack

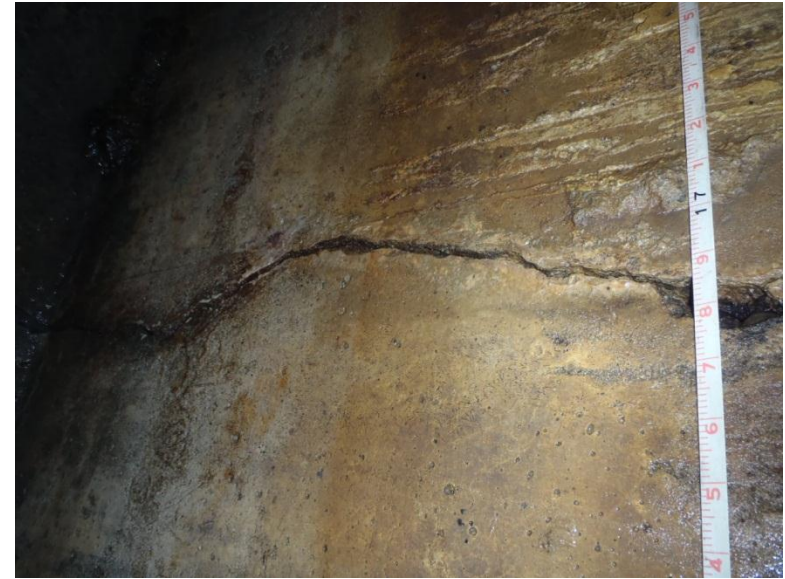
6) Sta 16 Left Side Horizontal Crack

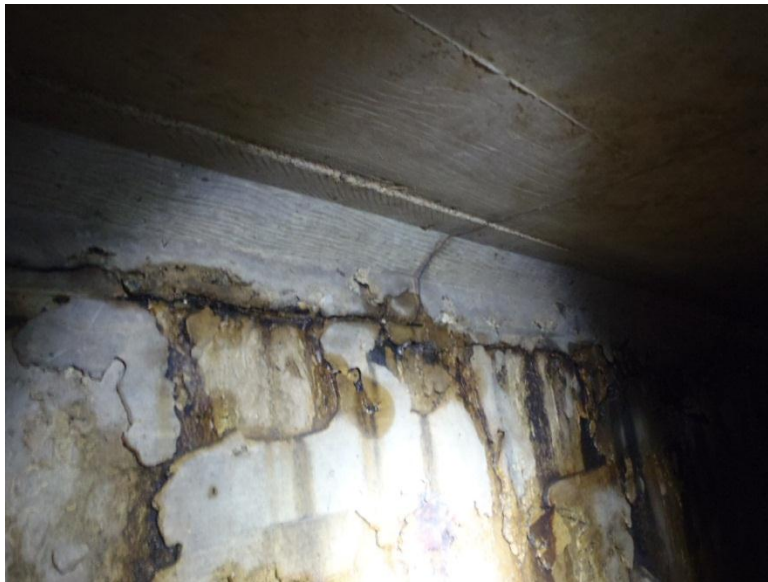
7) Sta 30 Left Side Longitudinal Cold Joint/Crack

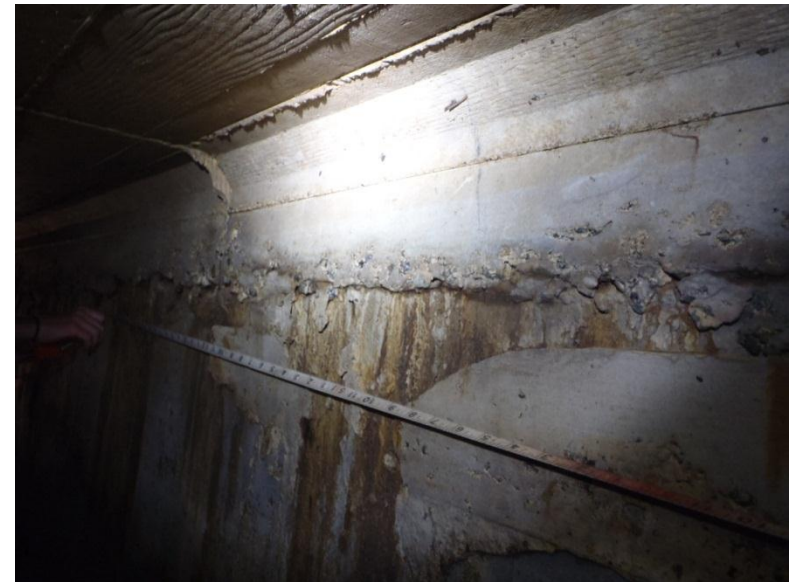
8) Sta 51 Right Side Cold Joint/Crack

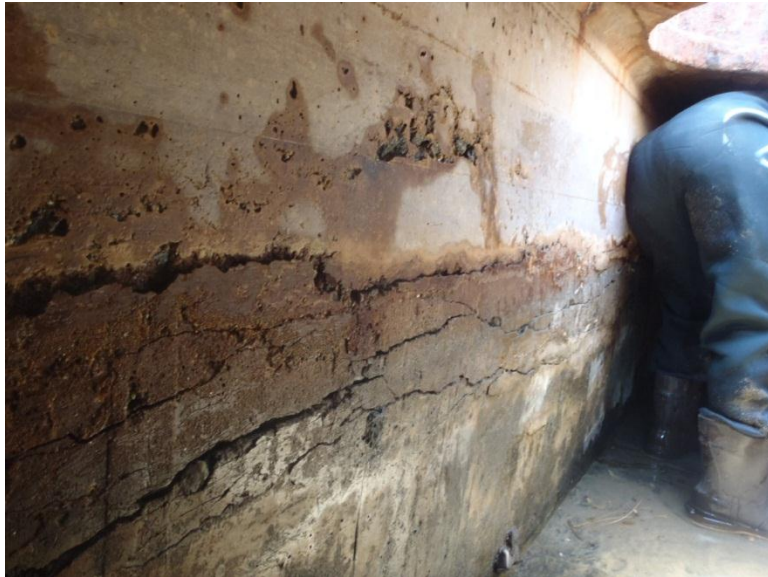
9) Sta 128 Left Side Longitudinal Cold Joints

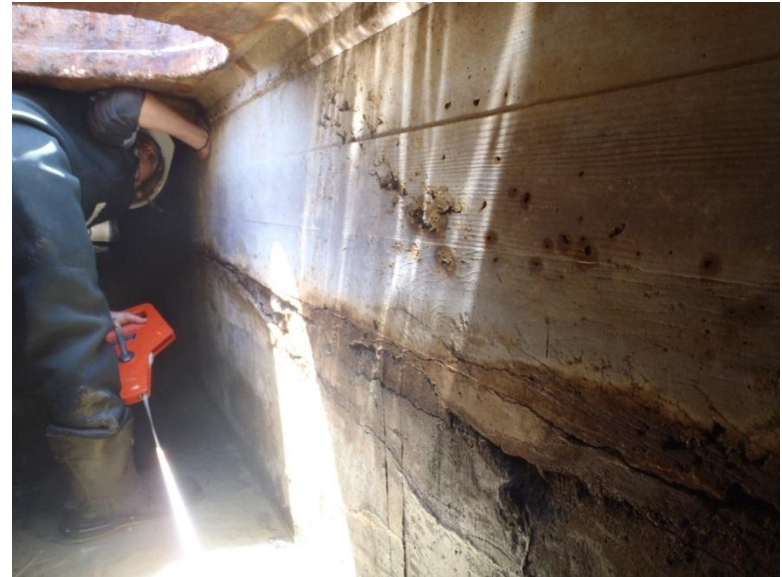
10) Sta 128 Right Side Longitudinal Cold Joint/Crack

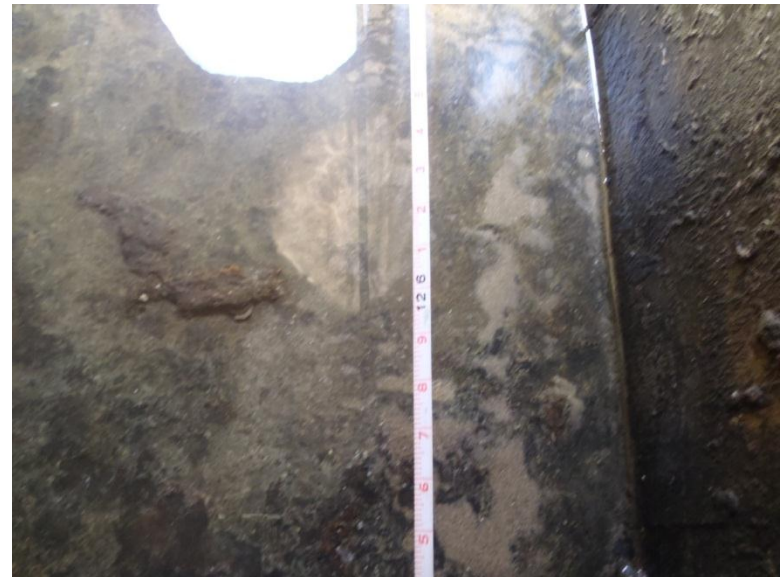
12) Sta 128 Floor, No Visible Cracks

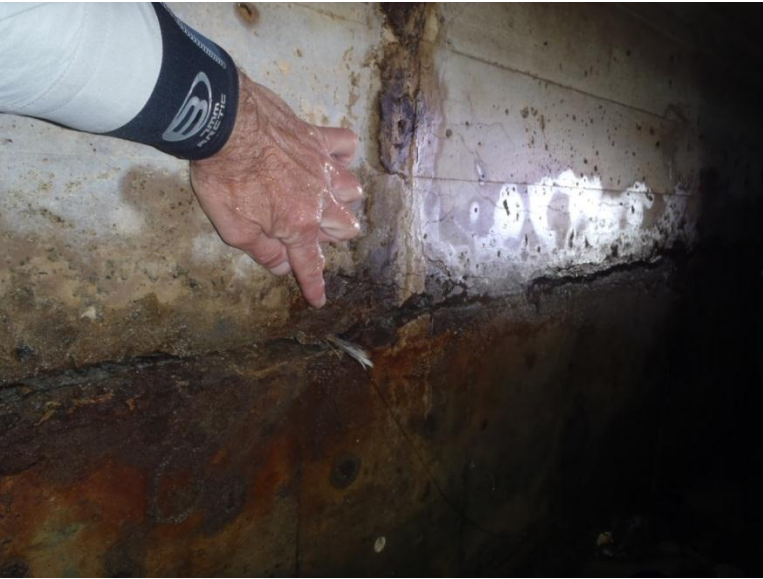
13) Sta 145 Cold Joint with Outside Material Entering

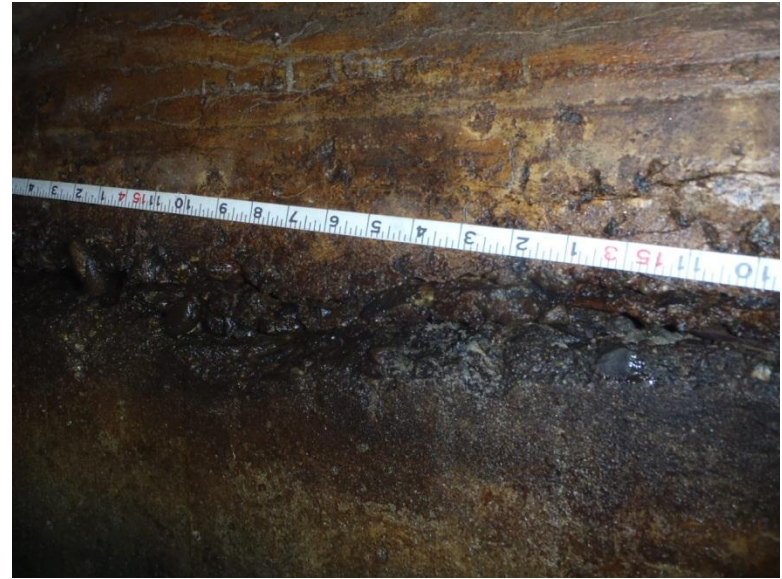
14) Sta 153 Cold Joint

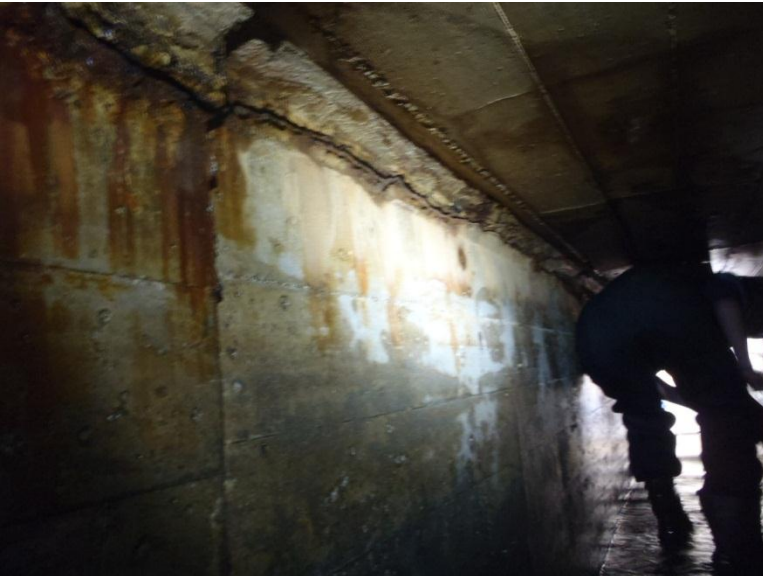
15) Sta 199 Left Side Crack at Top

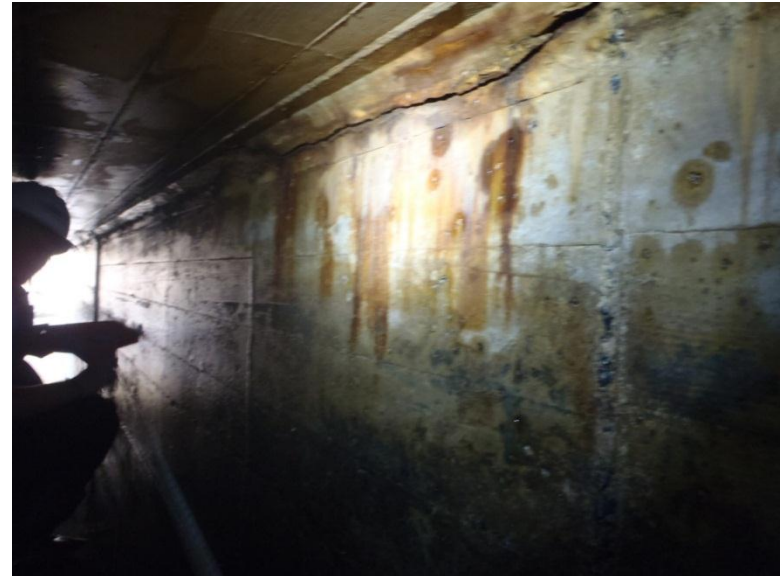
16) Right Side Crack at Top

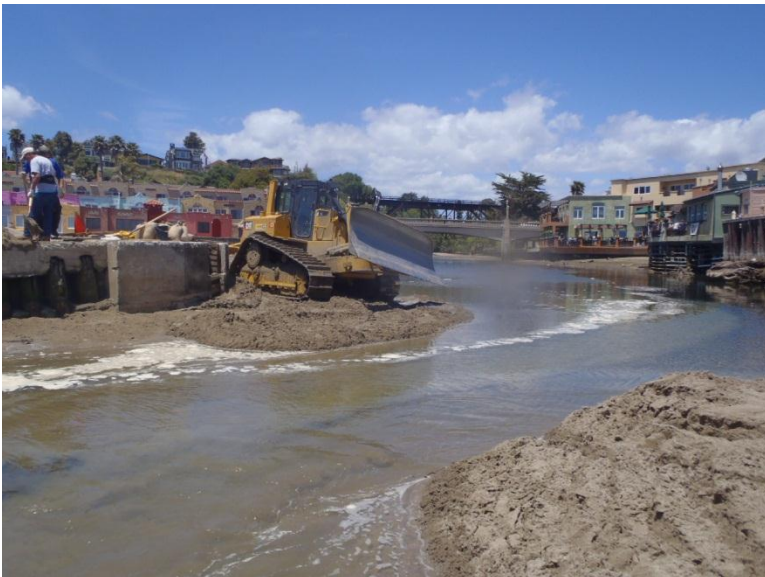
27) Lagoon Breach Prior to Closure
