RE: **ADDENDUM NO. 1**  
CAPITOLA BEACH FLUME AND JETTY REHABILITATION

# MEMORANDUM

**To:** Steve Jesberg, City of Capitola  
**From:** Brad Porter, PE *Brad Porter*  
**Date:** January 25, 2013  
**Subject:** Capitola Flume Rehabilitation-Concept Study  
**M&N Job No.:** 6628-01

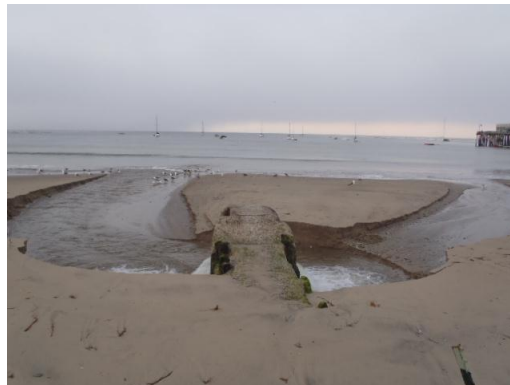
12-Outlet, Looking South

Observed operation of the flume with larger creek flow. It appears that the tide action may be undercutting the flume sand rather than leakage through the flume concrete. Both sides of the outlet were open to allow the larger flow to discharge.

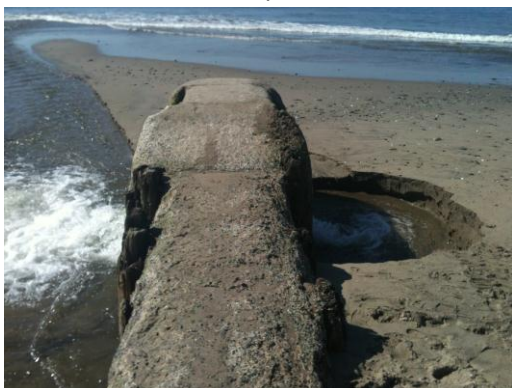
19-Outlet Looking South

One side of the outlet is open. The flow is less than it was in late spring in 2011. No signs of sinkholes are apparent. Sandbags are placed at the inlet with plastic sheeting to stop piping around the exterior of the flume that would create voids in the sand.
